United States Fire Administration

Technical Report Series

High-rise Office Building Fire One Meridian Plaza Philadelphia, Pennsylvania

Federal Emergency Management Agency

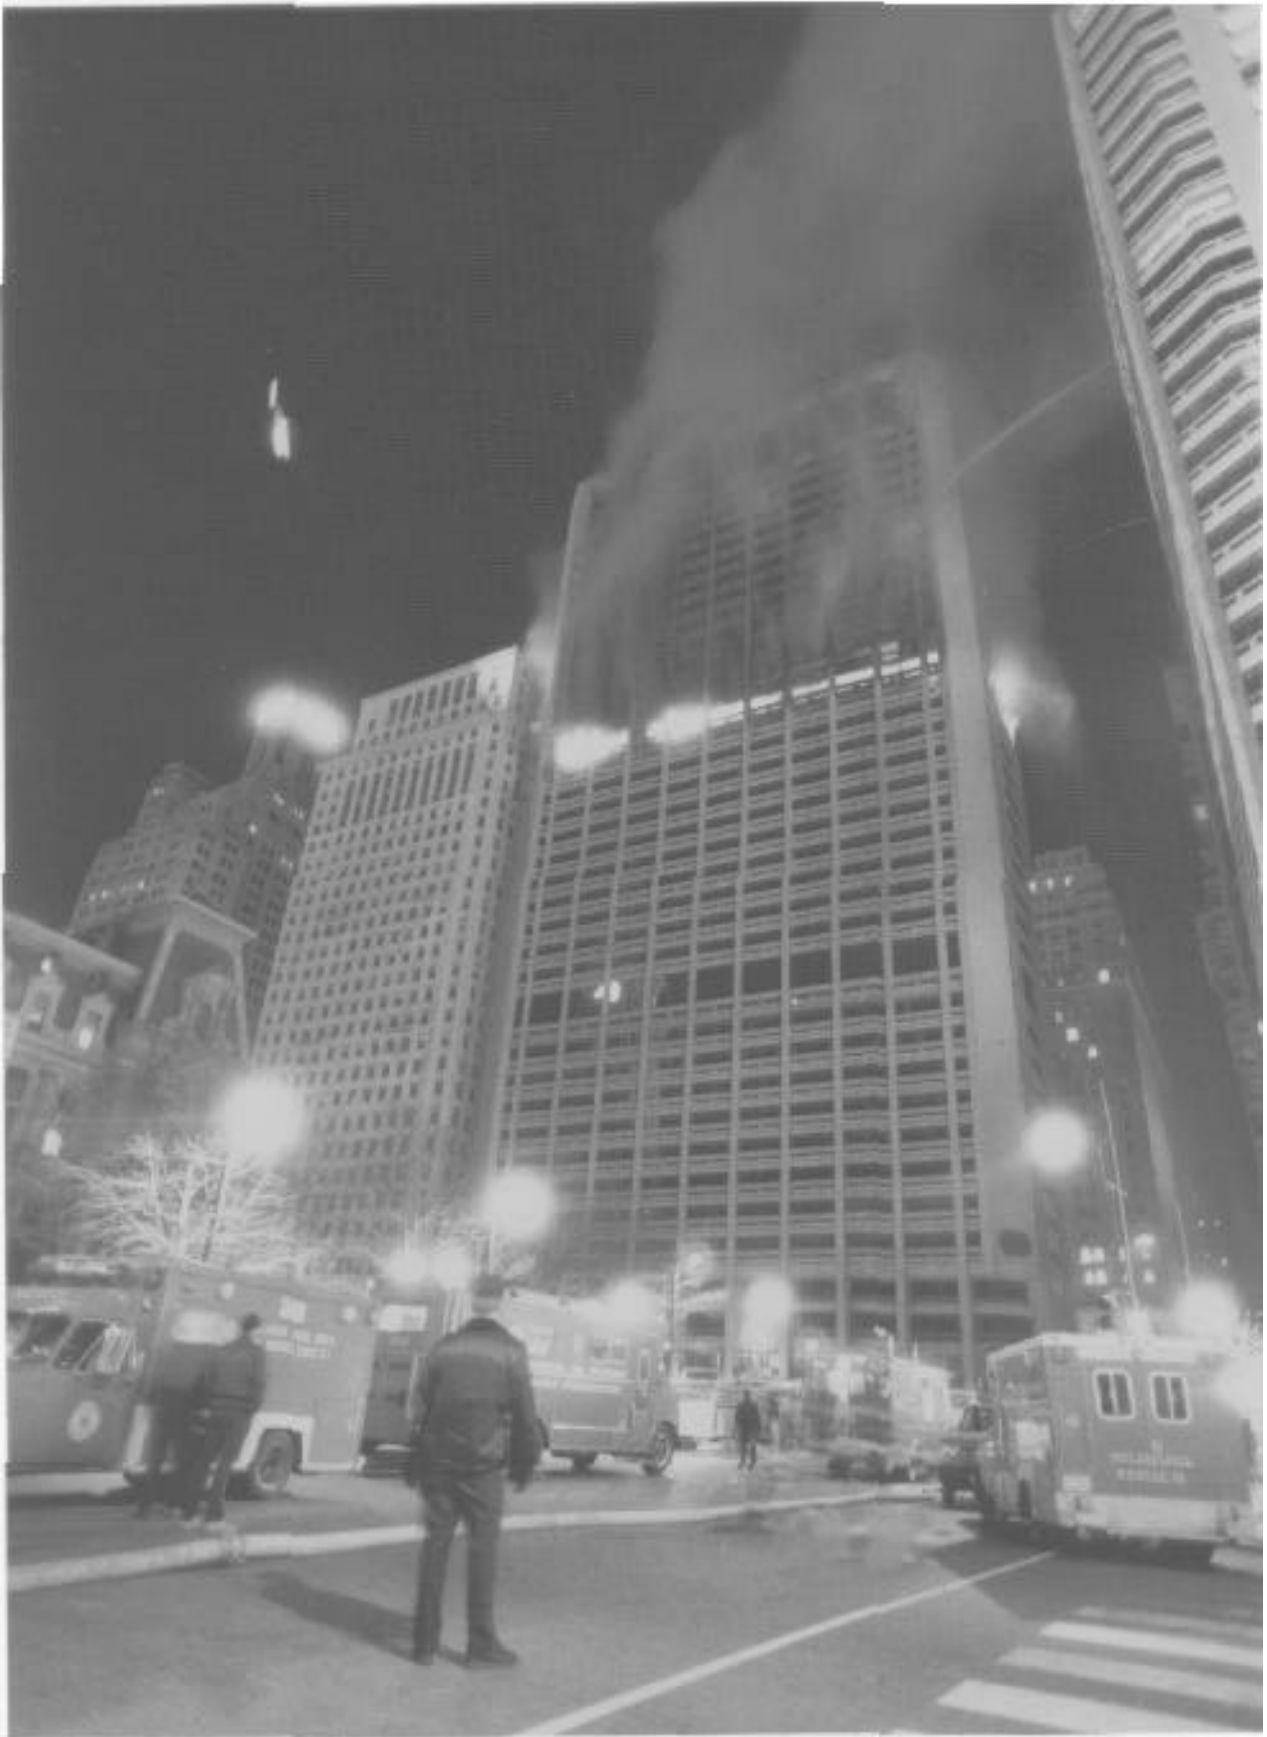
Exterior view of One Meridian Plaza and fireground operations in the early morning hours of February 24,1991. Fire involves the 22nd, 23rd, 24th, and part of the 25th floors. Note the heavy stream played on the exterior from an adjacent building.

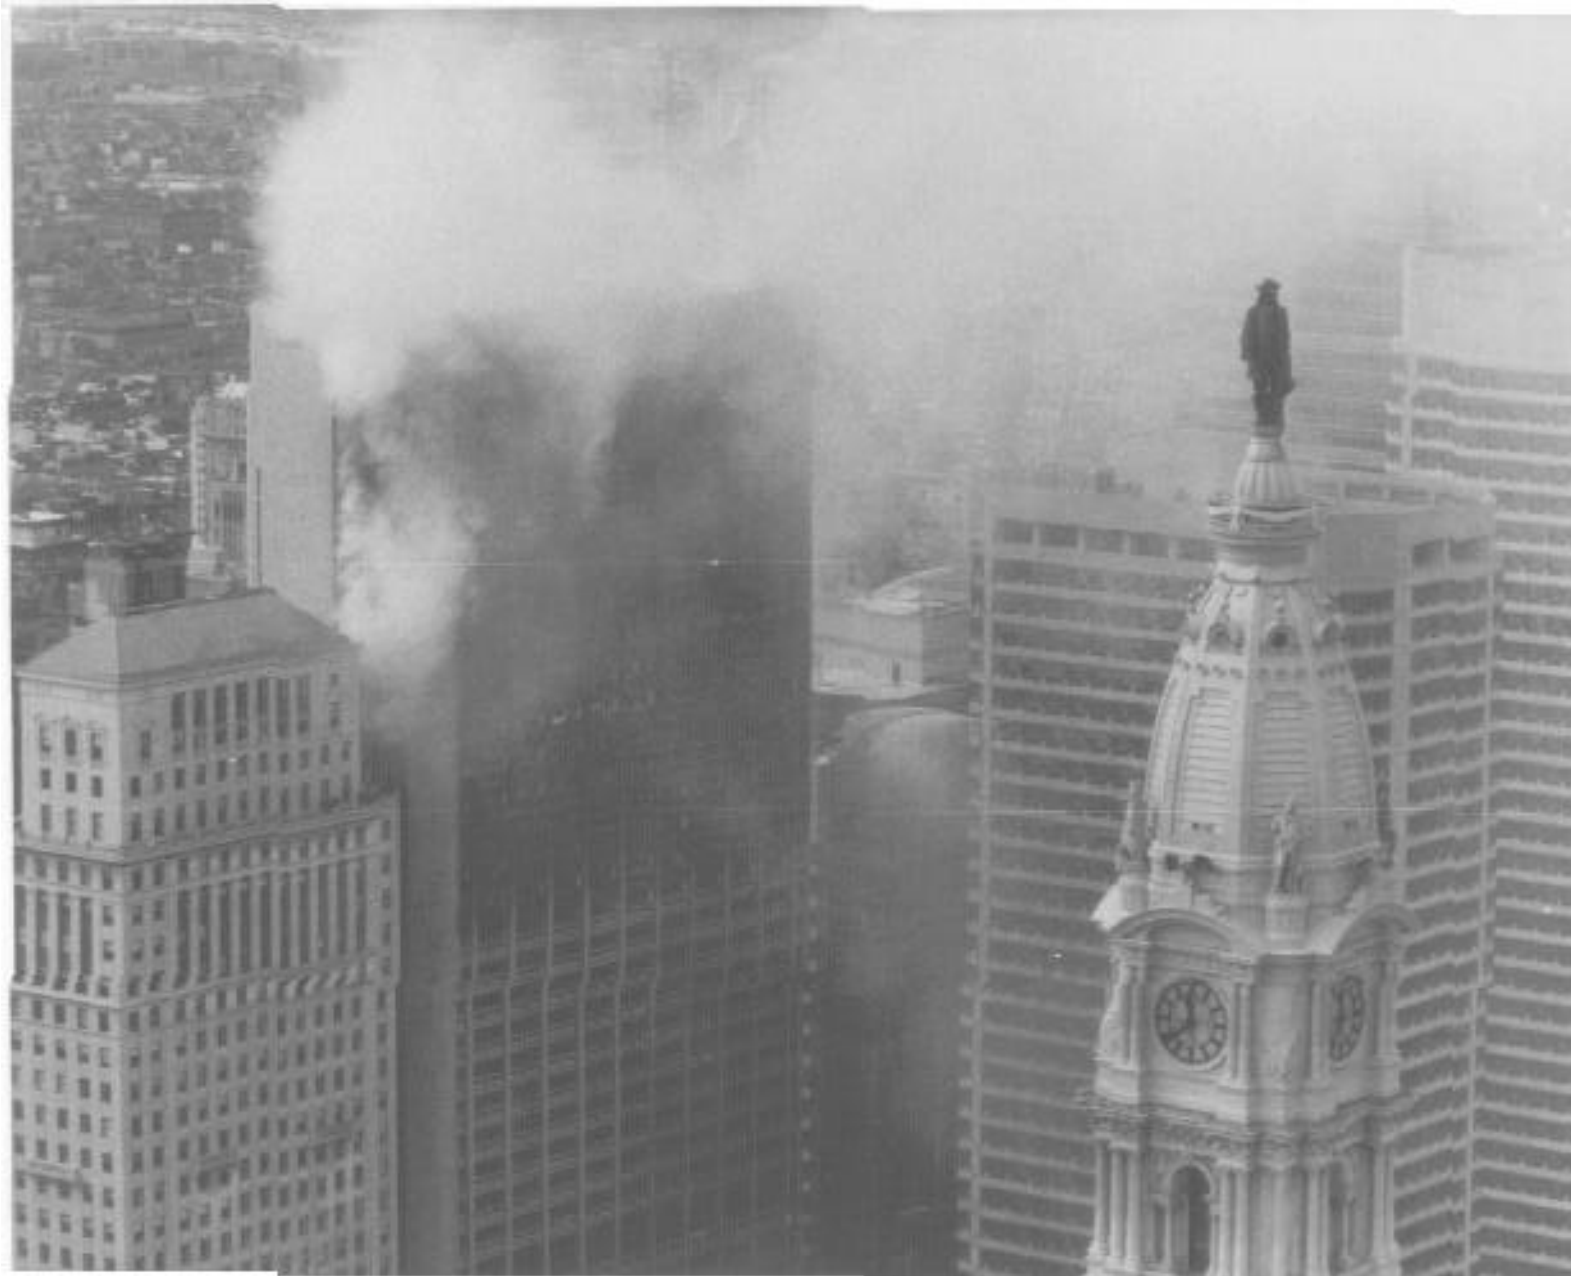
Smoke pours from One Meridian Plaza as William Penn looks on from atop Philadelphia City Hall the morning of February 24, 1991, after interior firefighting efforts have been suspended.

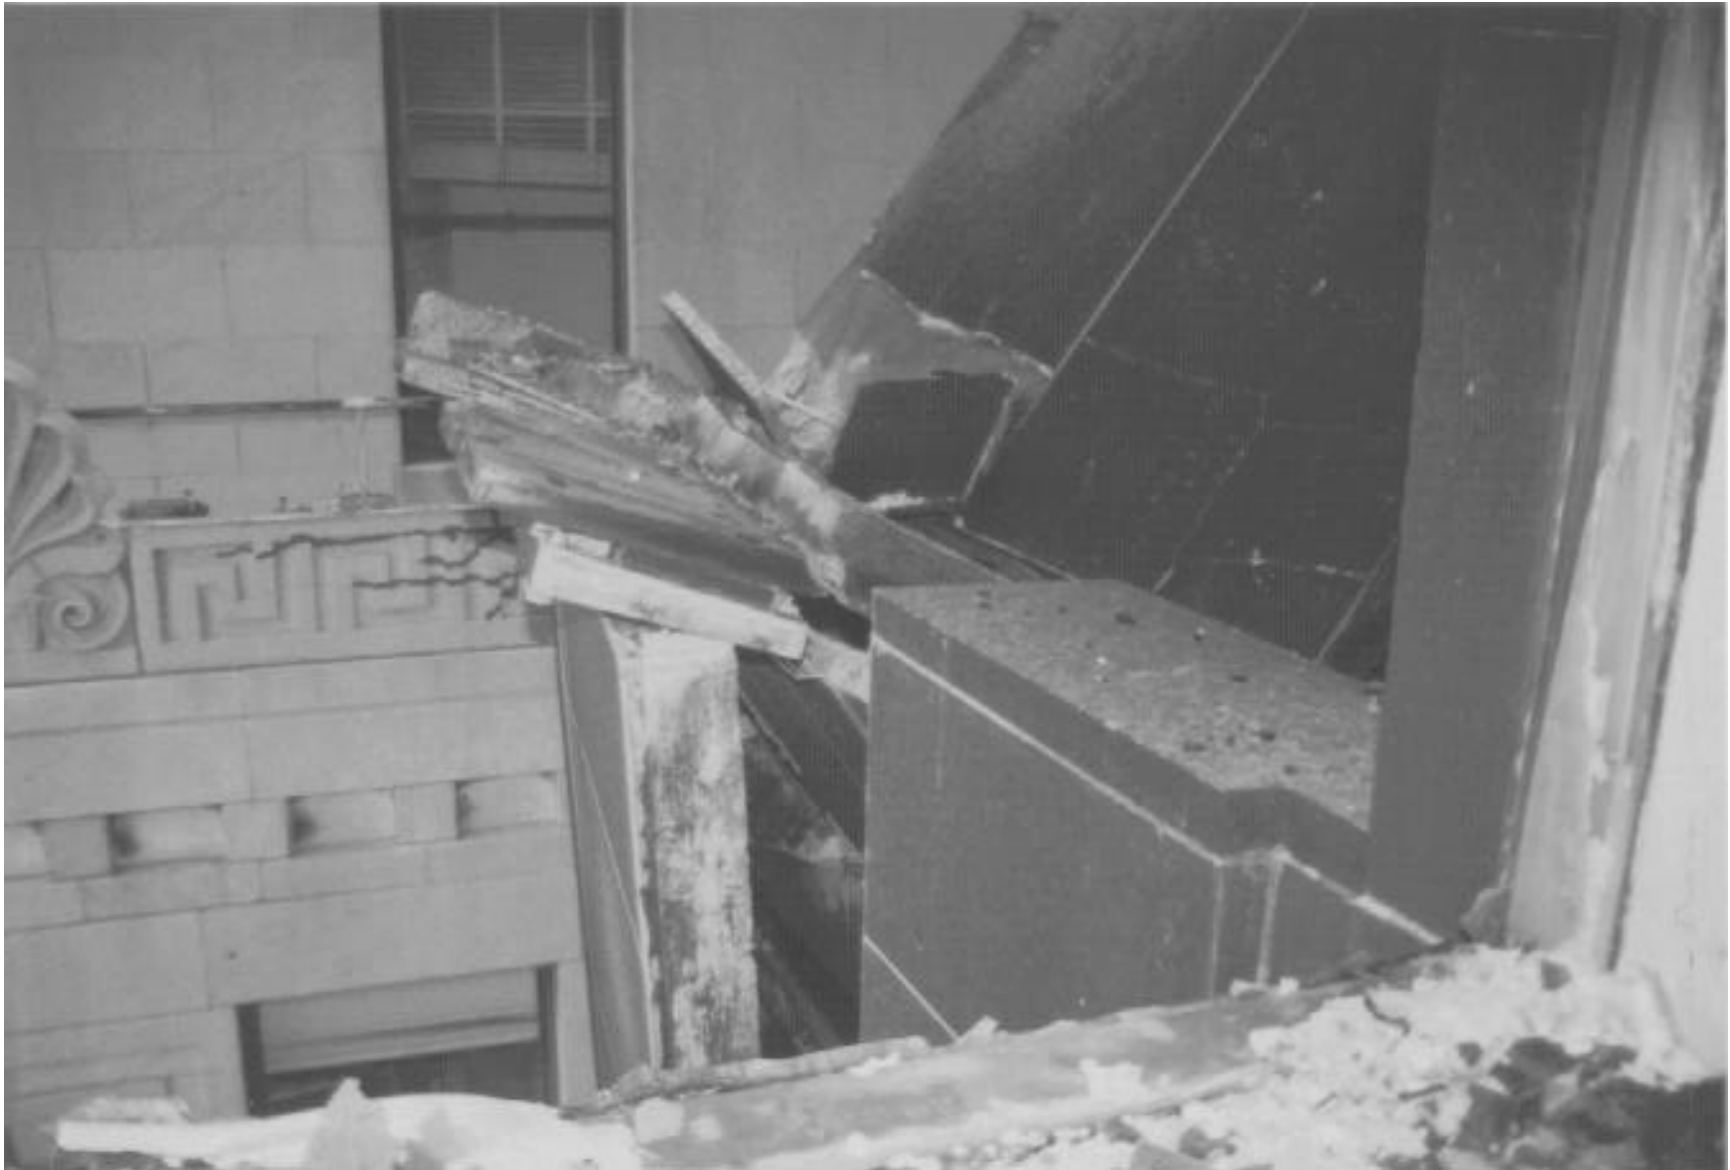
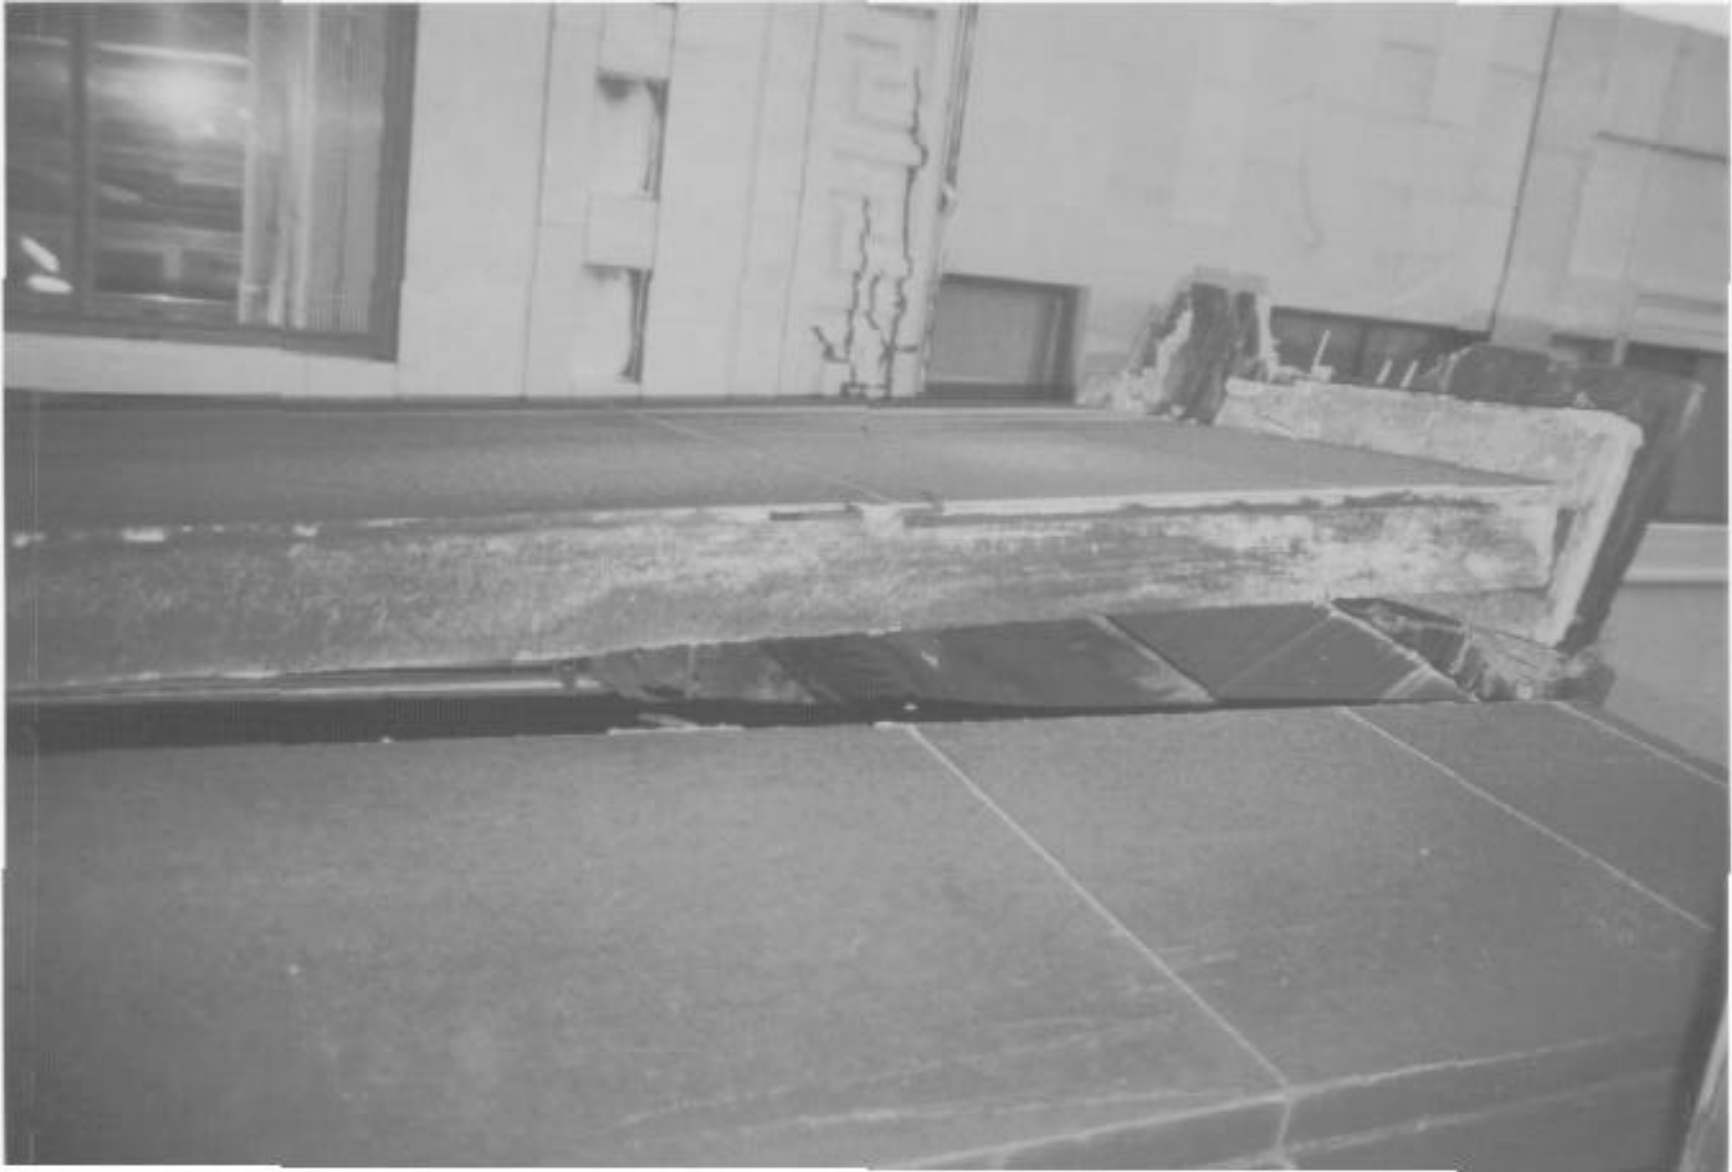
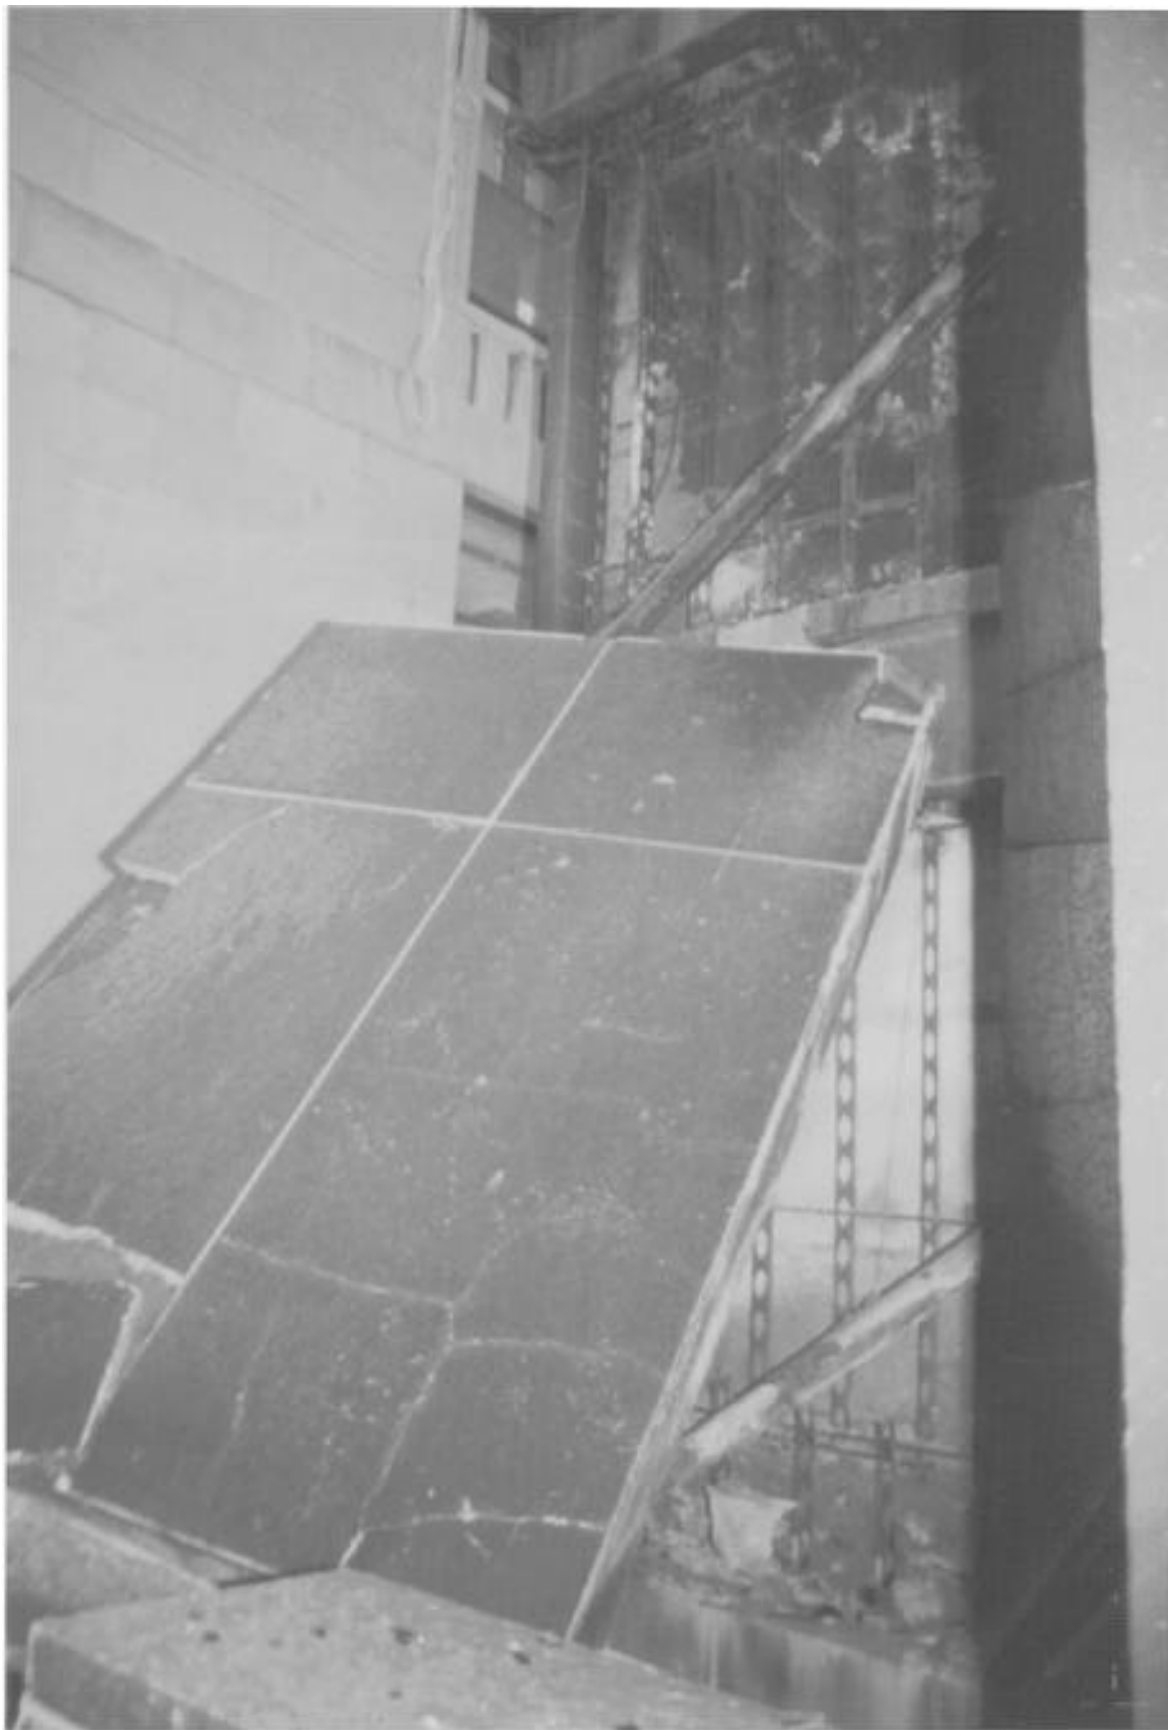
Here and in the next two photos exterior granite panels from the east stair tower were dislodged due to the thermal expansion of the steel frame of the building.

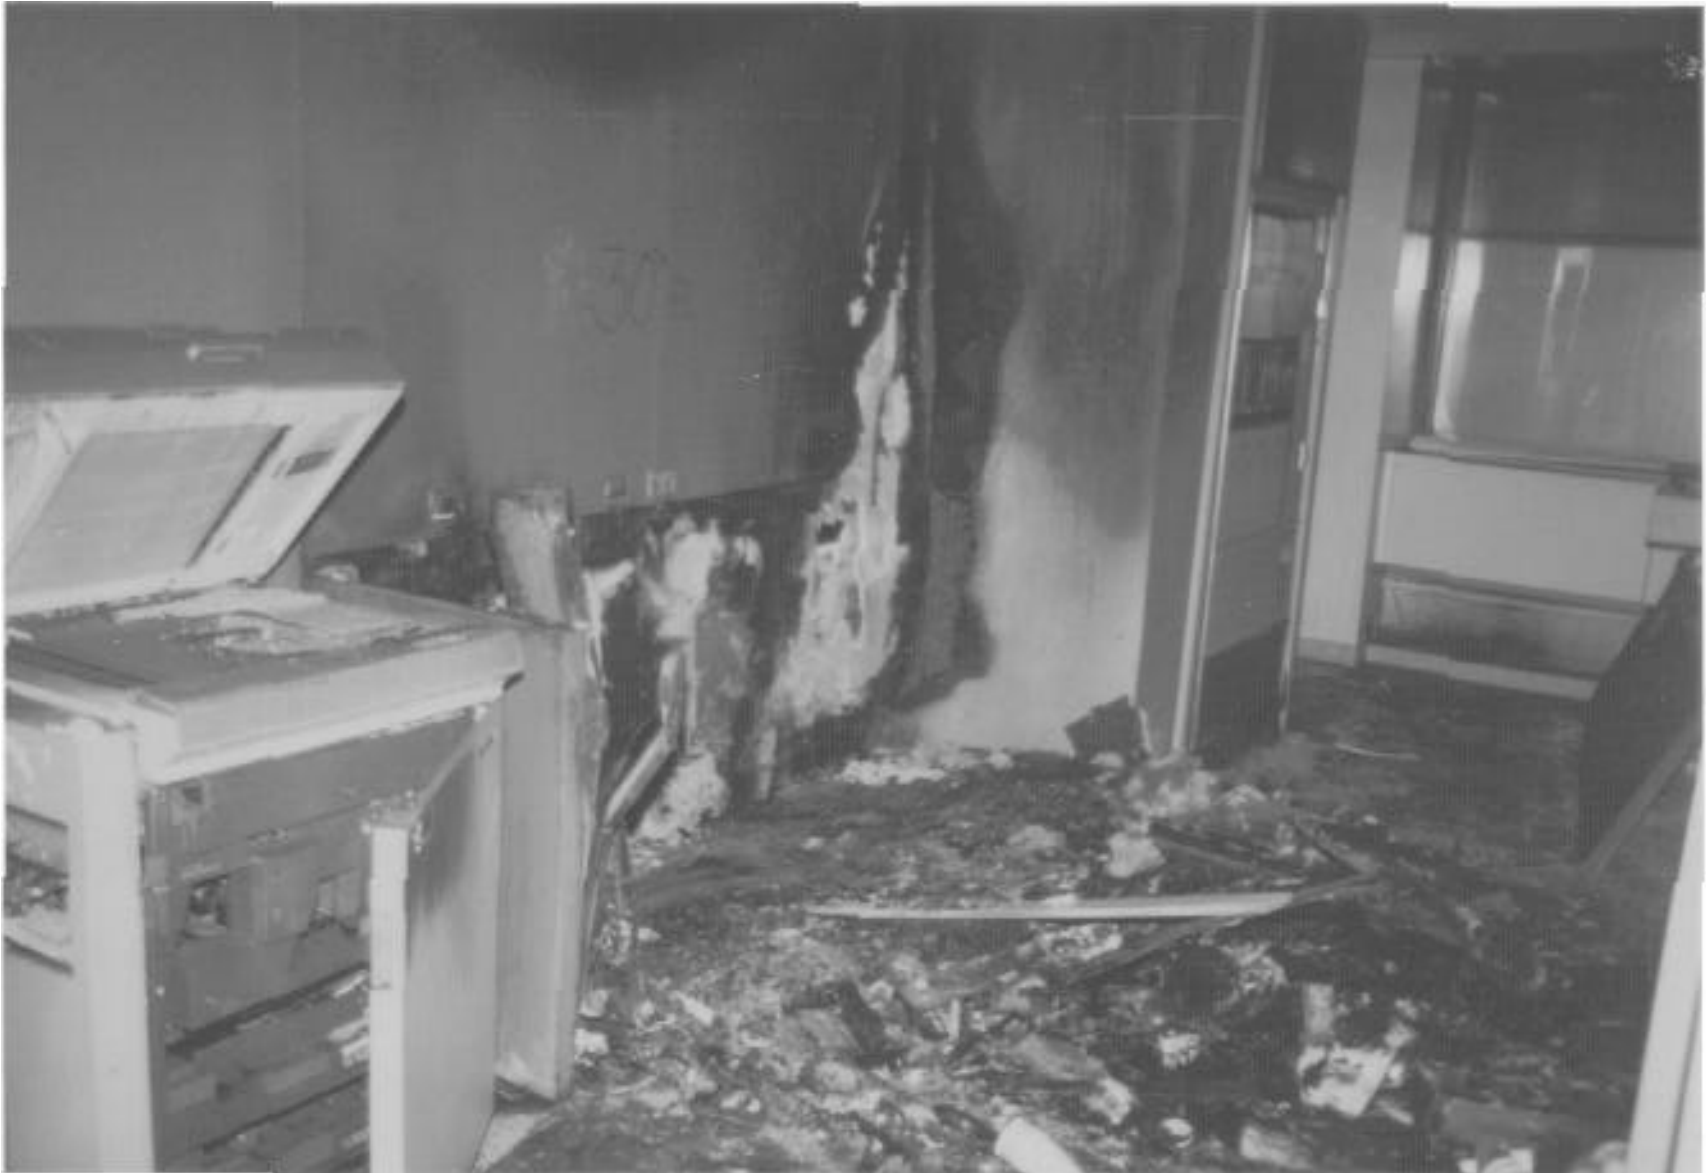
The fire was stopped when it reached the 30th floor, which was protected by automatic sprinklers. As the fire ignited in different points this floor level through the floor assembly and by autoexposure through the windows, 10 sprinkler heads activated and the fires were extinguished at each point of penetration. The vertical spread of the fire was stopped solely by the action of the automatic sprinkler system, which was being supplied by Fire Department pumpers. The 30th floor was not heavily damaged by fire, and most contents were salvageable. The fire was declared under control at 3:01 p.m., February 24, 1991.

One of the areas of fire penetration on the 30th floor where a single sprinkler head activated to stop the upward extension of the fire.

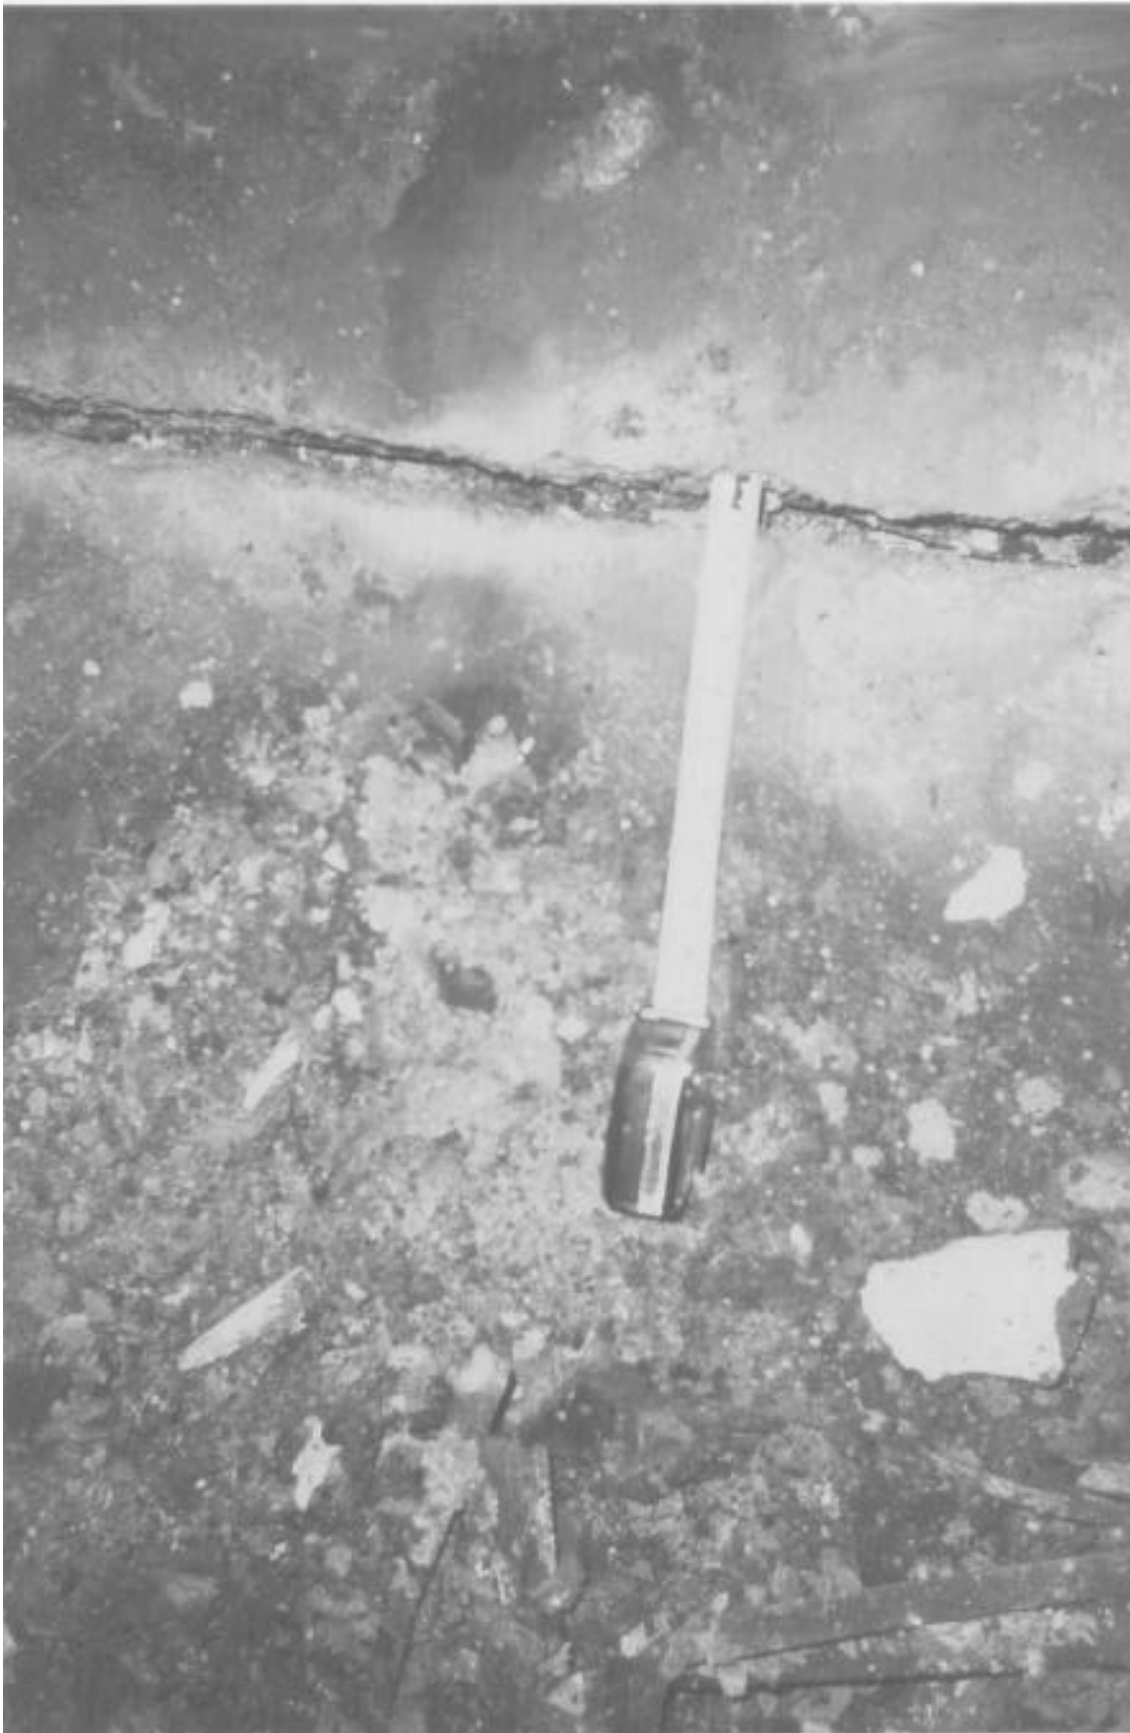
Prior to deciding to evacuate the building, firefighters noticed significant structural displacement occurring in the stair enclosures. A command officer indicated that cracks large enough to place a man's fist through developed at one point. One of the granite exterior wall panels on the east stair enclosure was dislodged by the thermal expansion of the steel framing behind it. After the fire, there was evident significant structural damage to horizontal steel members and floor sections on most of the fire damaged floors. Beams and girders sagged and twisted -- some as much as three feet -- under severe fire exposures, and fissures developed in the reinforced concrete floor assemblies in many places. Despite this extraordinary exposure, the columns continued to support their loads without obvious damage.

Close-up of crack in concrete floor, 28th floor.

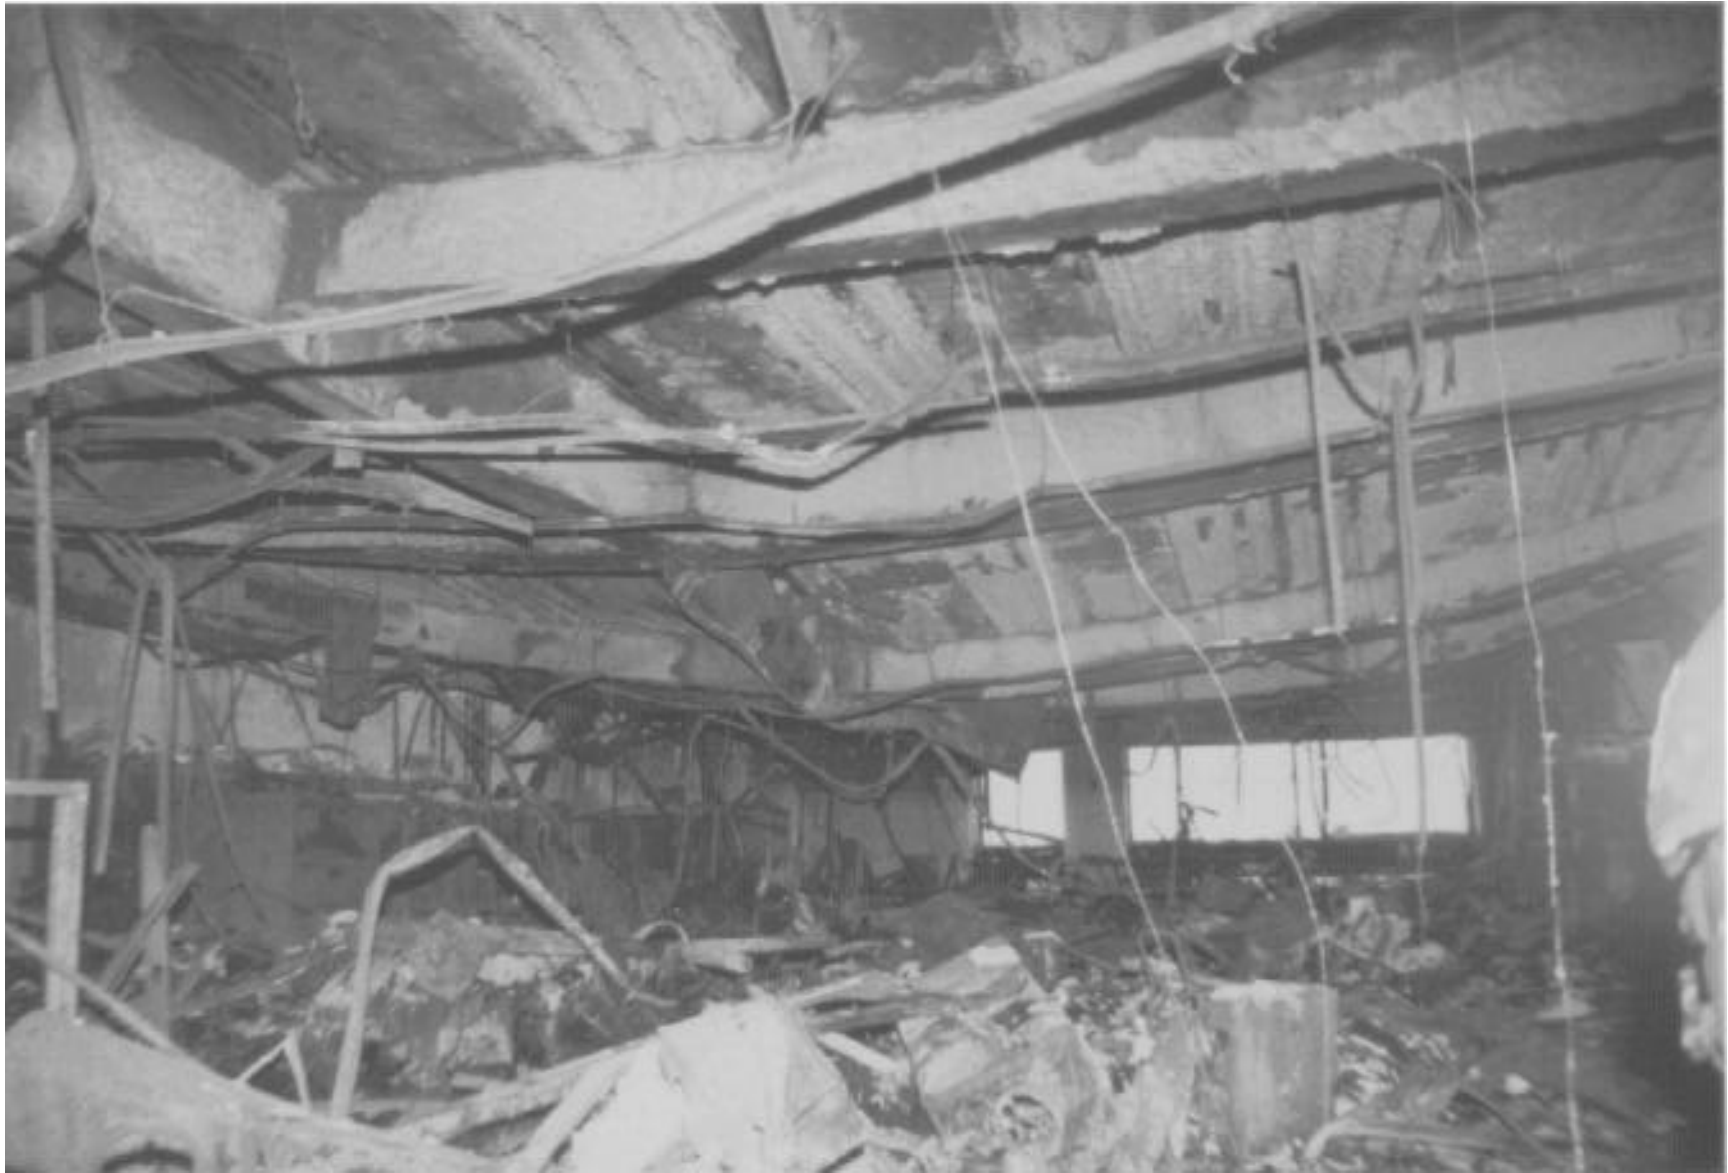
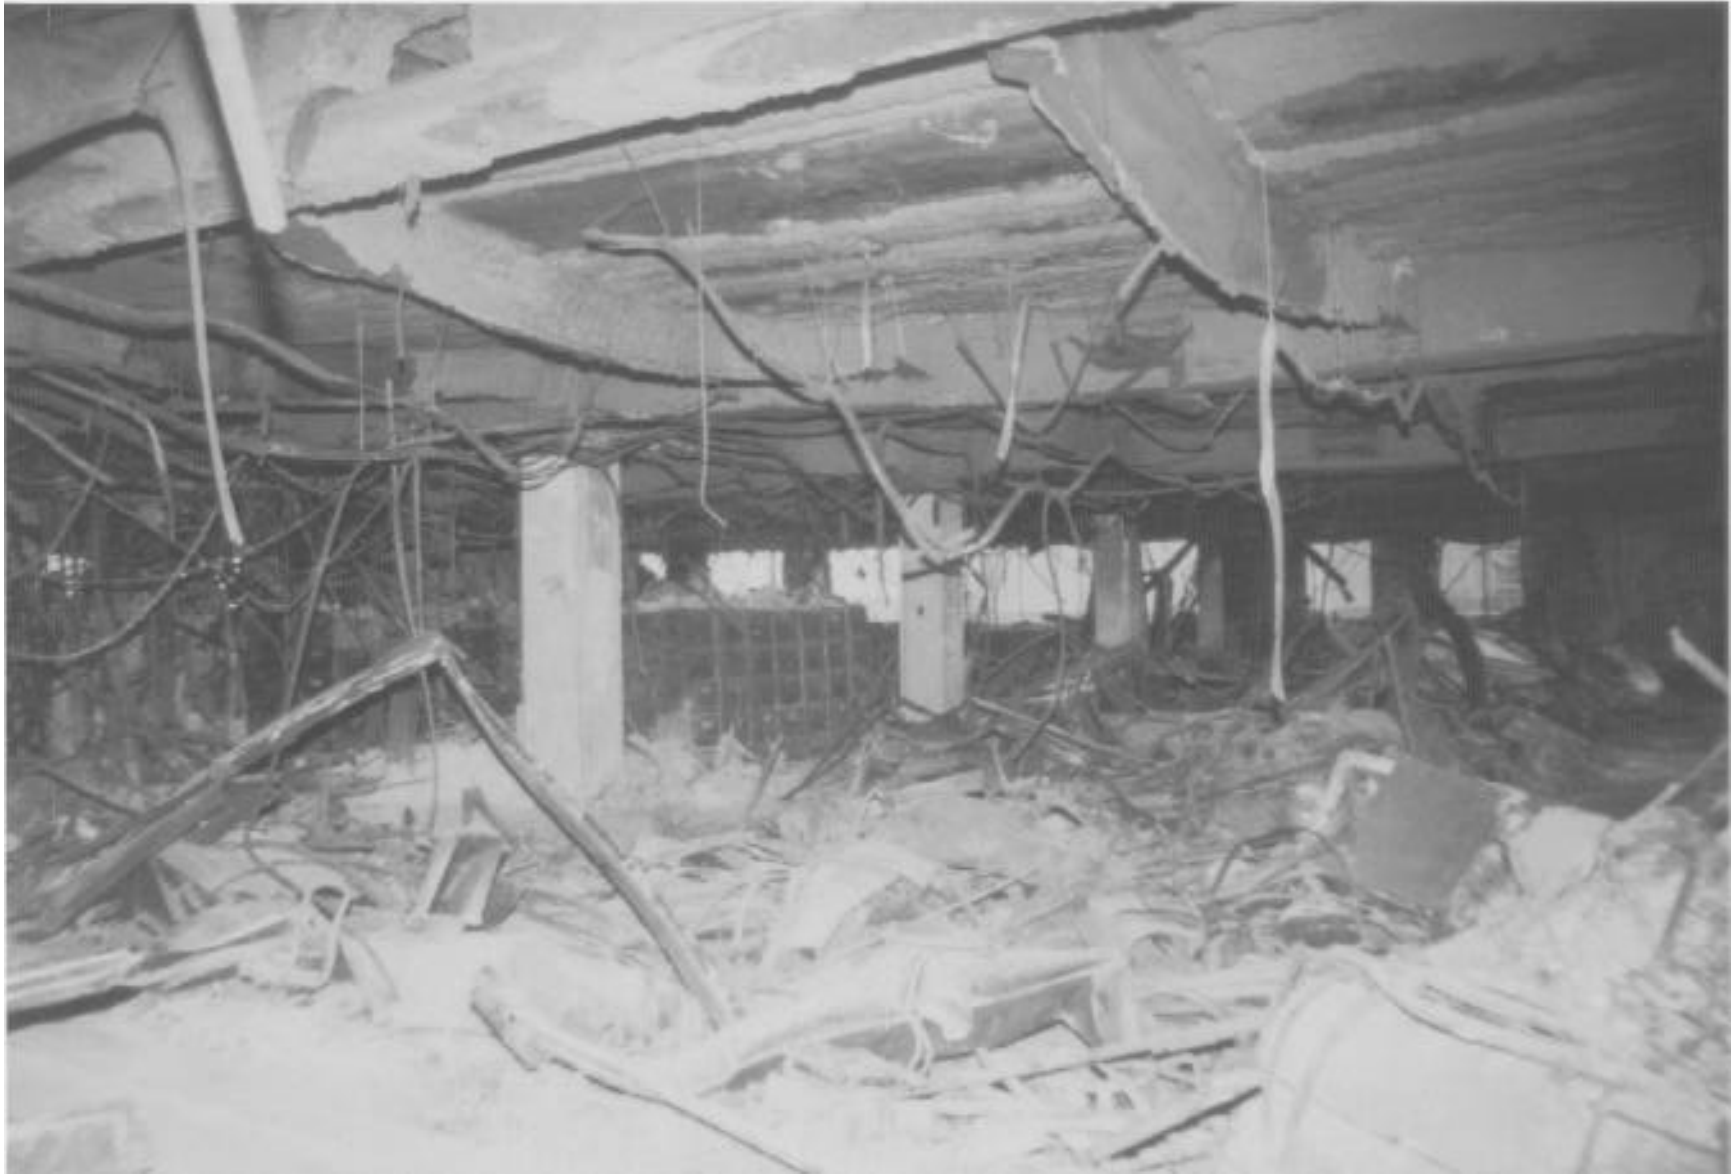
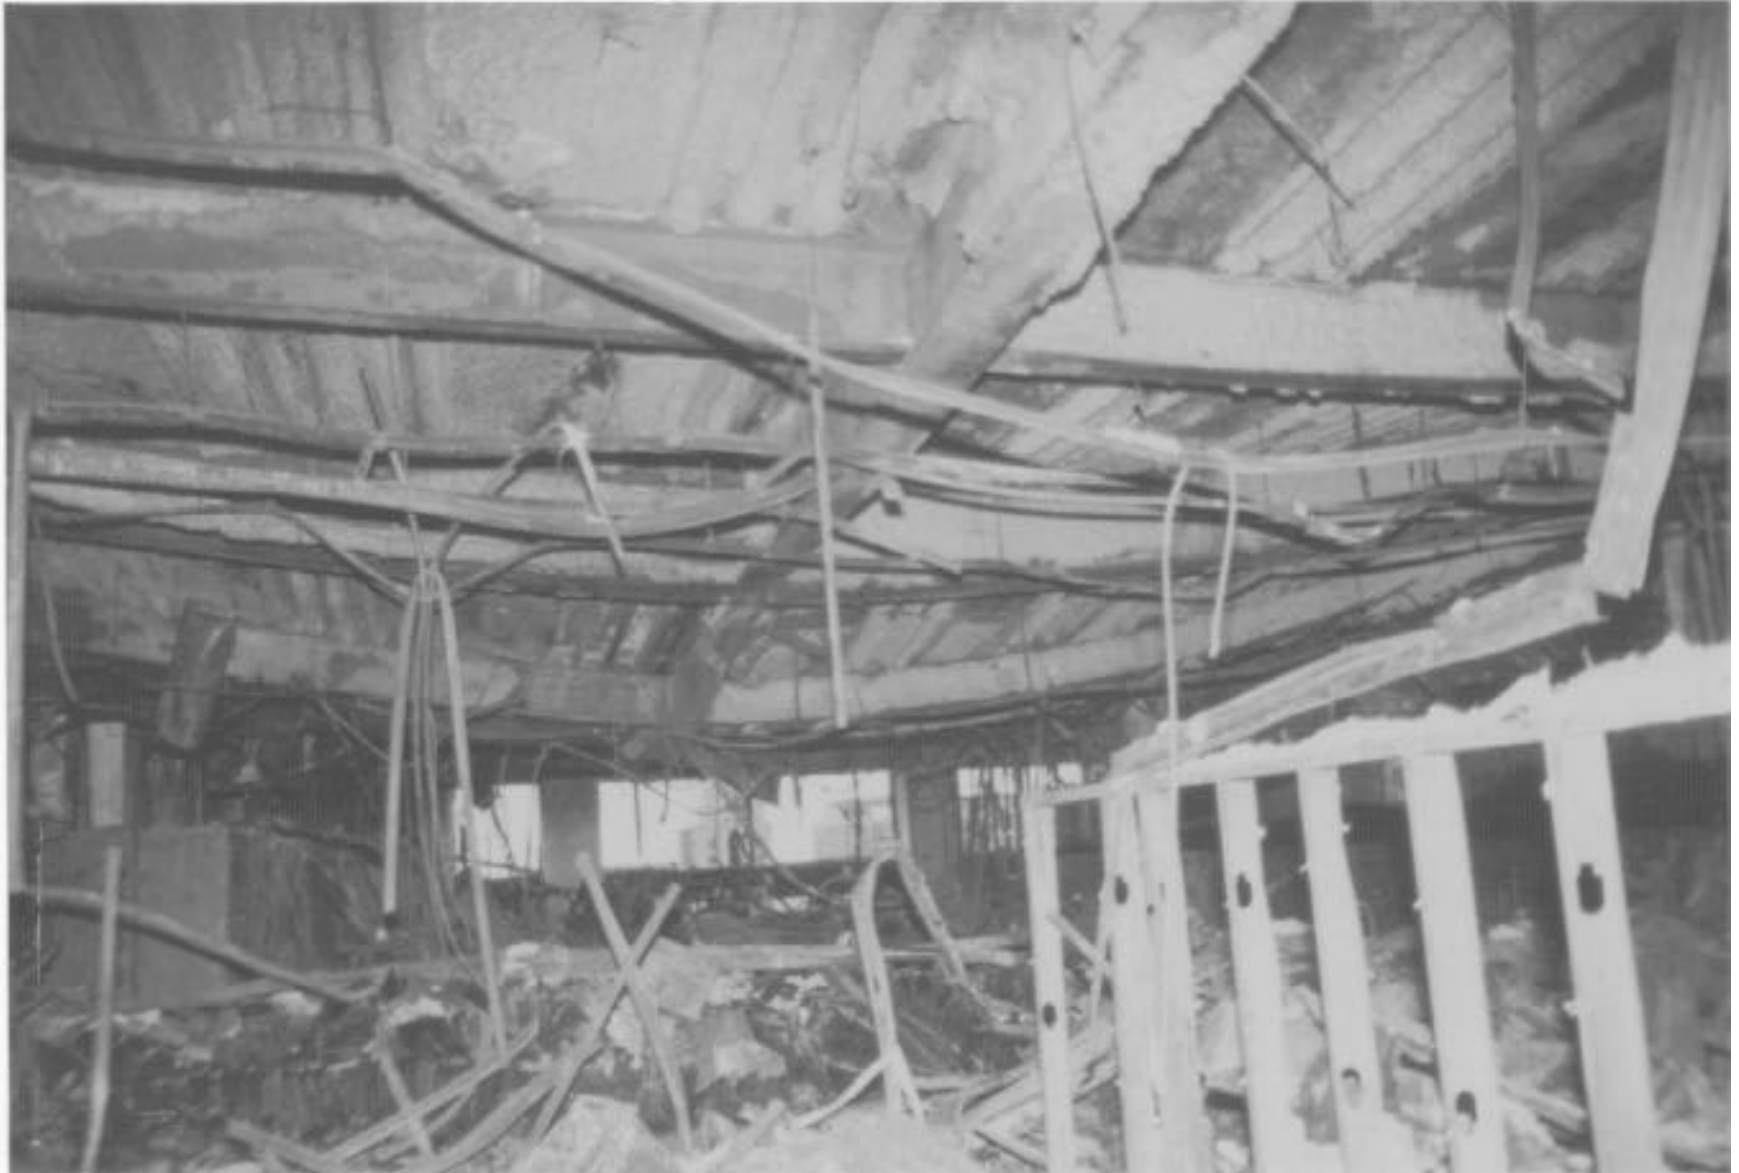
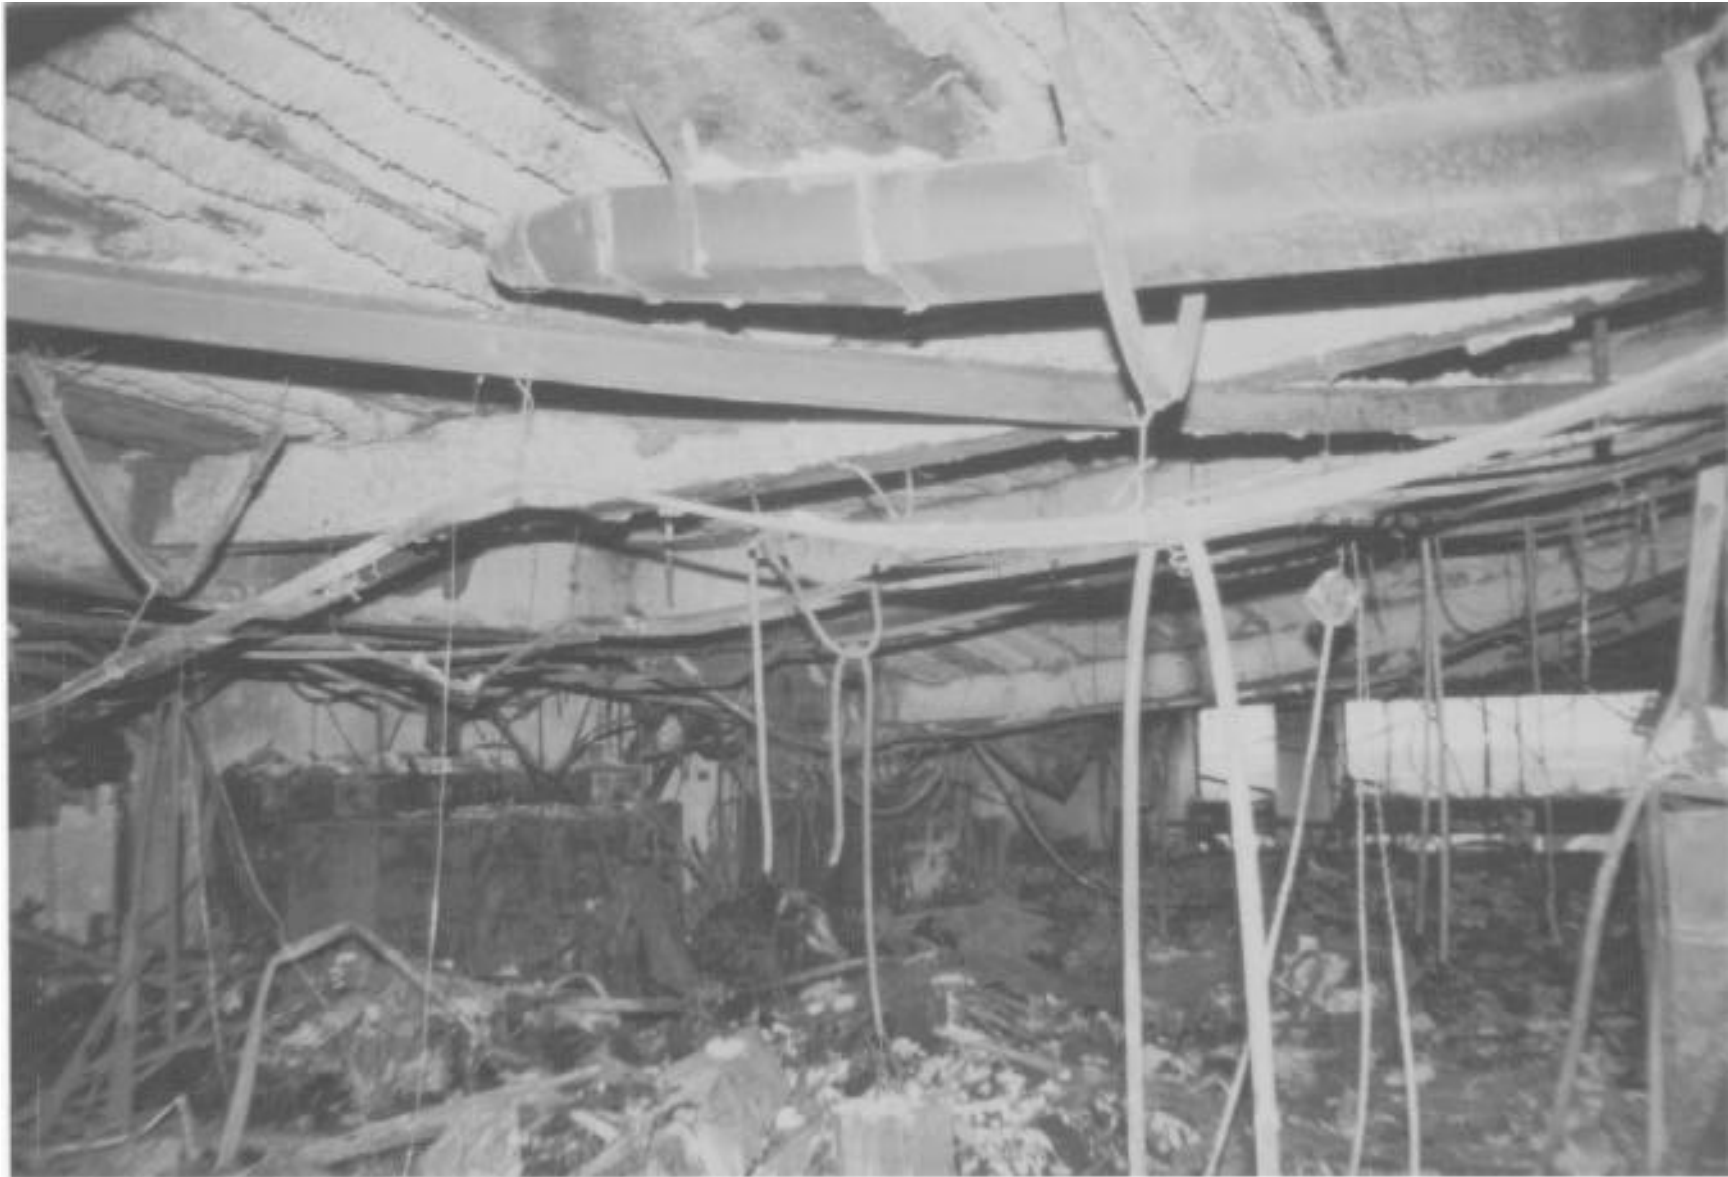
Here and in the next three photos are interior views of floor areas after the fire. Note the total consumption of the available fuel and sagging of the floor deck of up to three feet between columns.
