United States Fire Administration

Technical Report Series

High-rise Office Building Fire One Meridian Plaza Philadelphia, Pennsylvania

Federal Emergency Management Agency

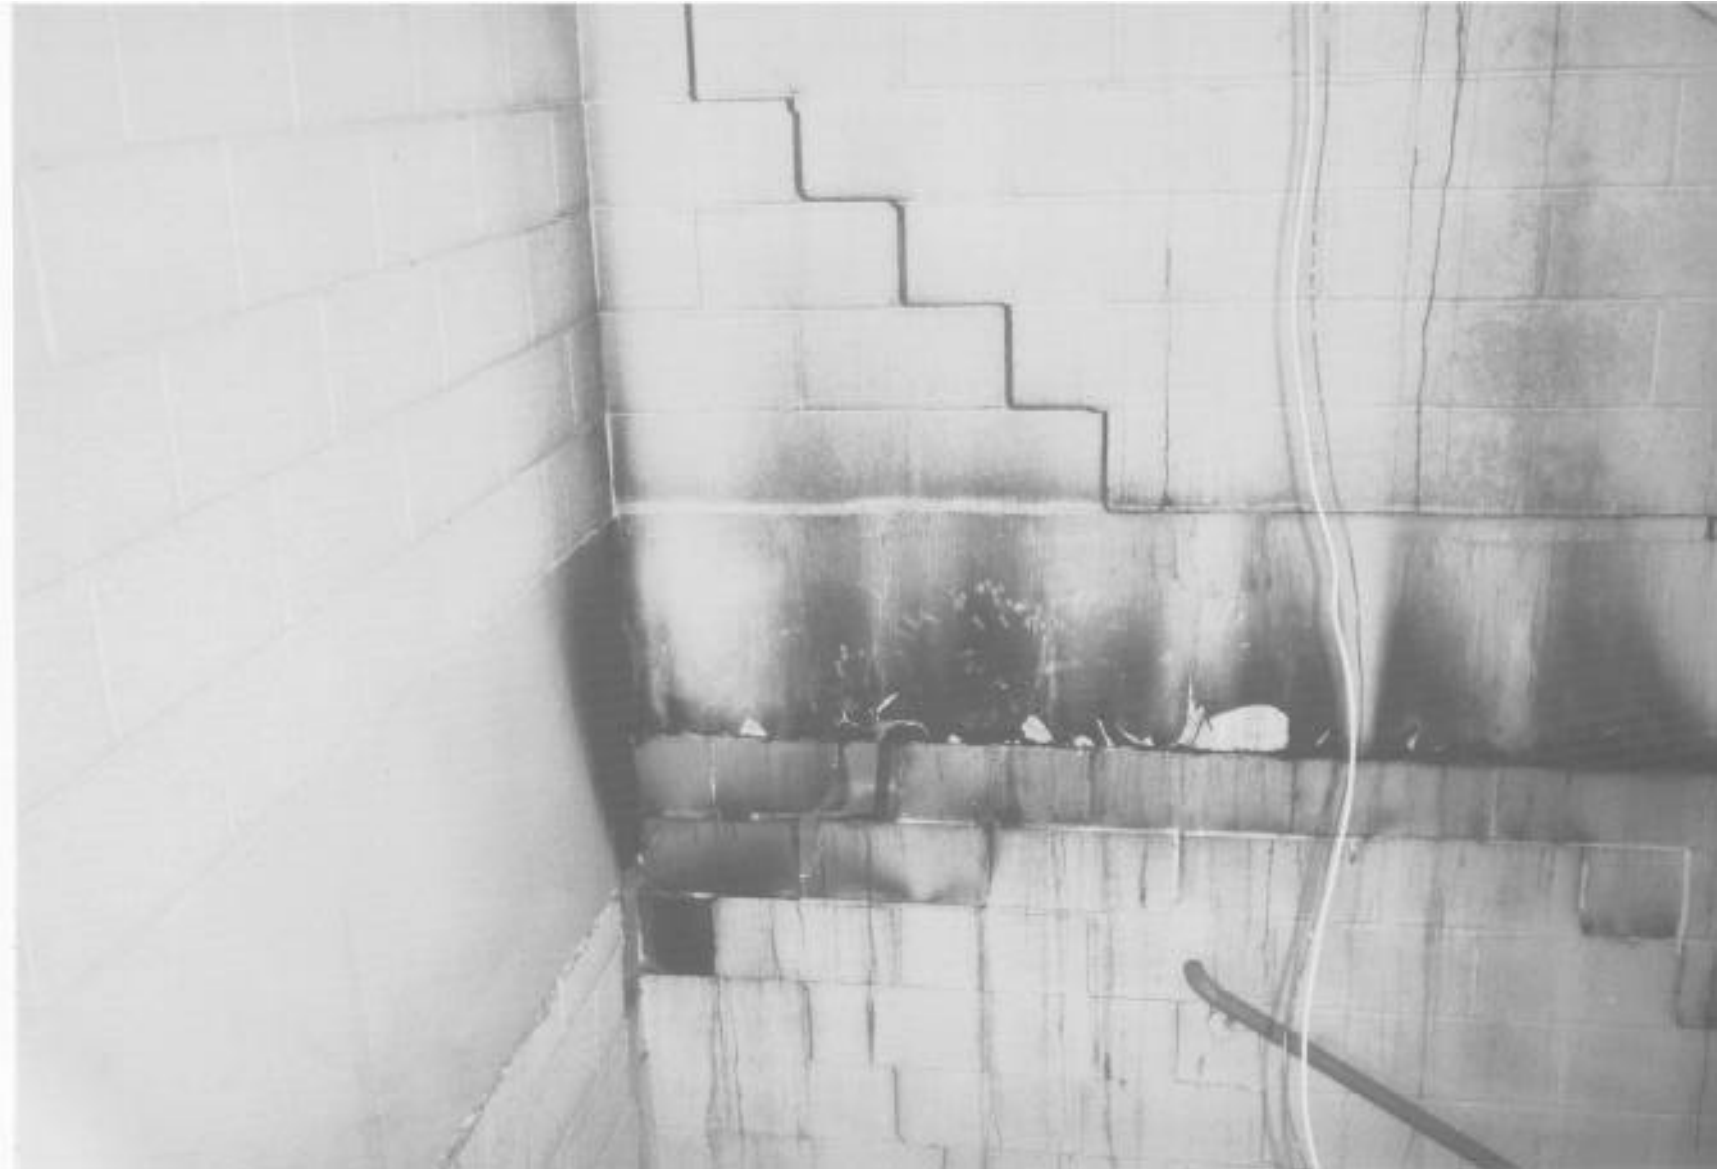
Fire tower between 25th and 26th floors. Note heavy fire and smoke damage.

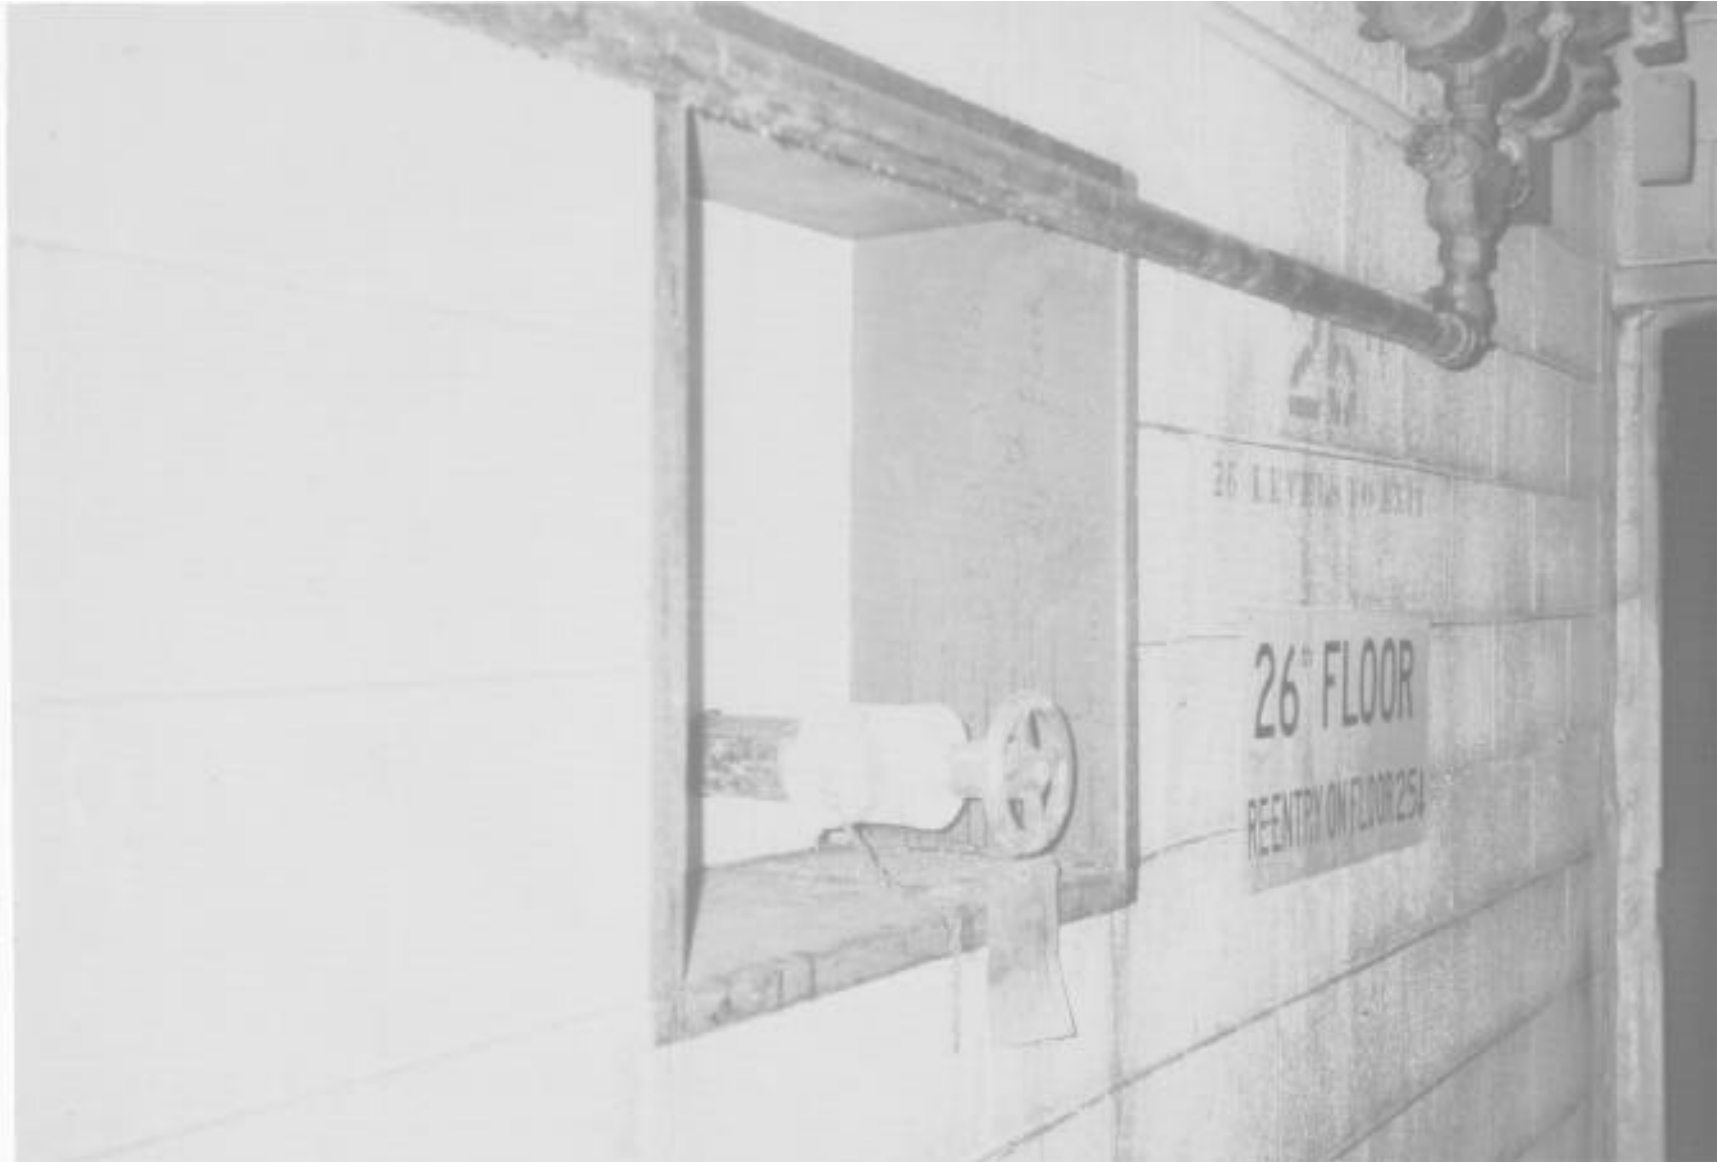
When the PRVs were originally installed, the pressure settings were improperly adjusted. Index values marked on the valves did not correspond directly to discharge pressures. To perform adjustments the factory and field personnel had to refer to tables in printed installation

Several fire department pumpers were connected to the Fire Department connections to the standpipe system in an attempt to increase the water pressure. The improperly set PRVs effectively prevented the increased pressure in the standpipes from being discharged through the valves. The limited water supply prevented significant progress in fighting the fire and limited interior forces to operating from defensive positions in the stairwells. During the next hour the fire spread to the 23rd and 24th floors primarily through autoexposure, while firefighters were unable to make entry onto these floors due to deteriorating heat and smoke conditions and the lack of water pressure in their hose lines. Windows on the 22nd floor broke out and the 23rd and 24th floor windows were subject to autoexposure from flames lapping up the sides of the building.

Standpipe hose outlet with pressure reducing valve (PRV), 26th floor.

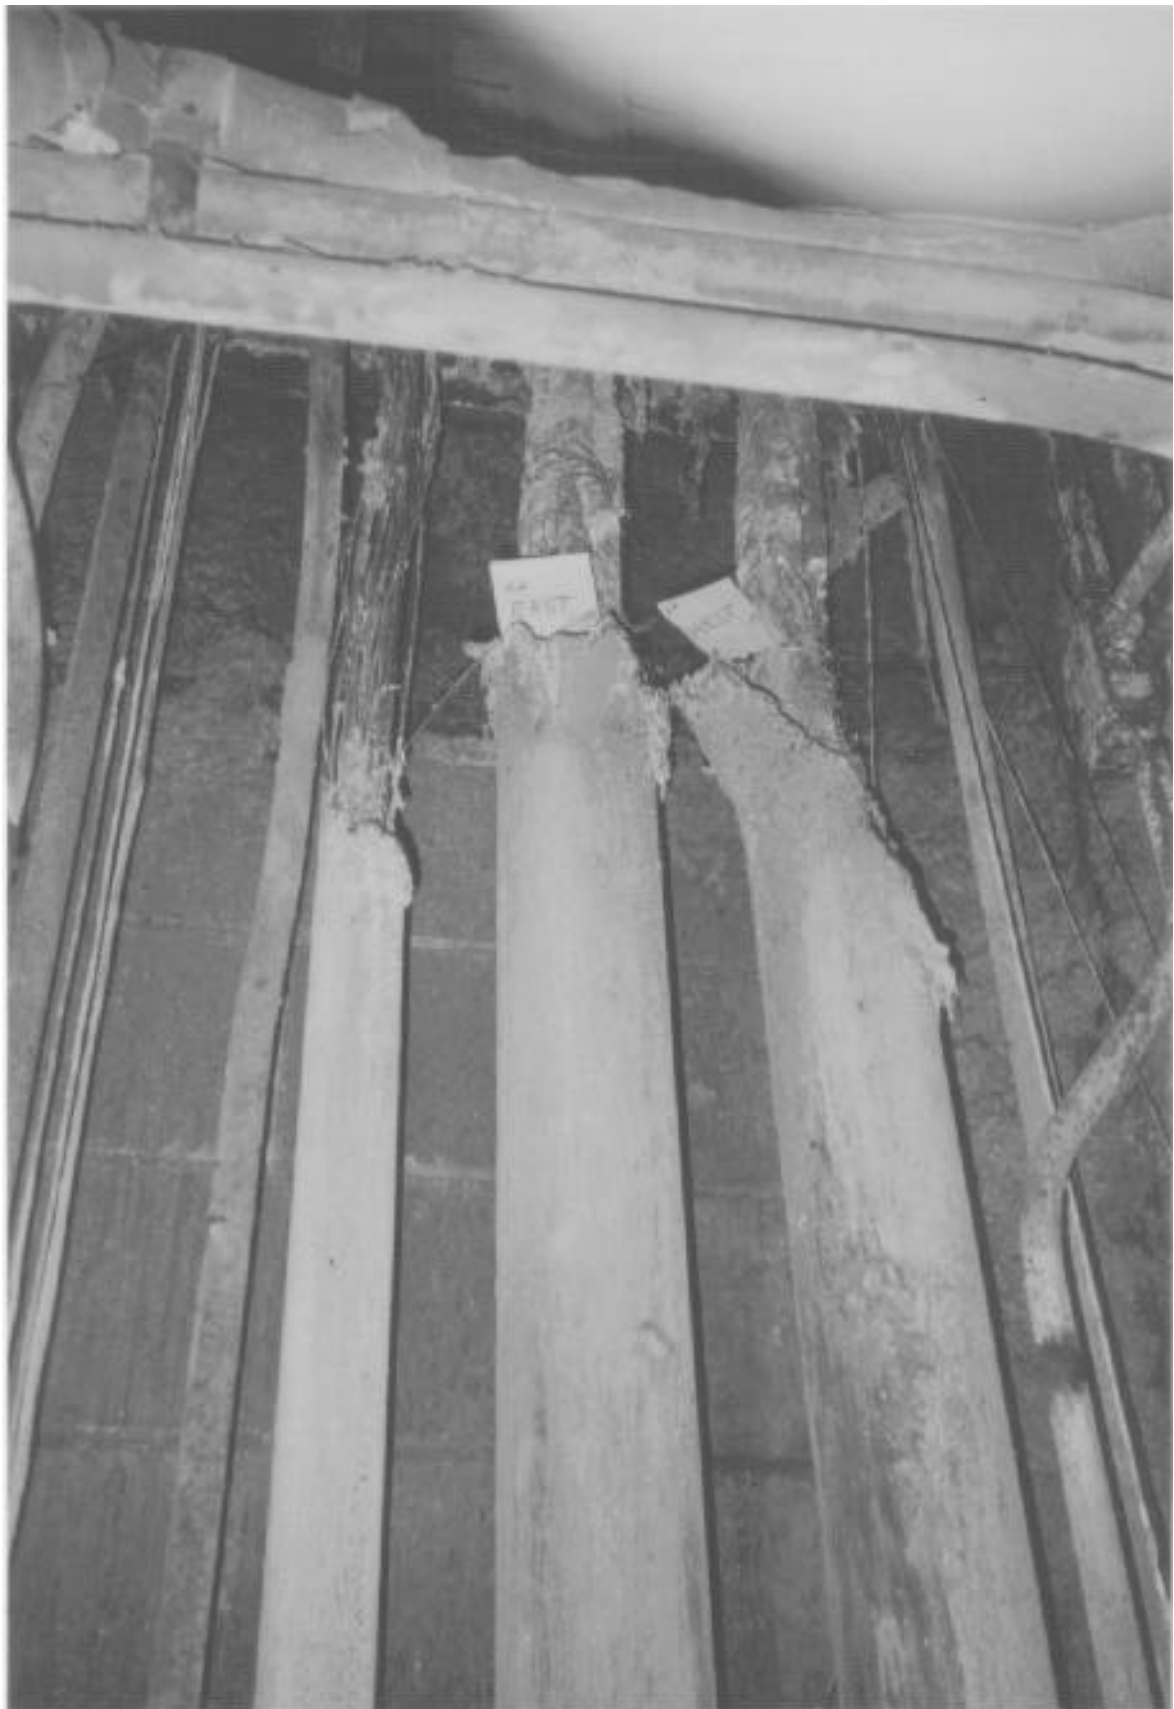
Electrical Systems	Installation of the primary and secondary electrical power risers in a common unprotected enclosure resulted in a complete power failure when the fire-damaged conductors shorted to ground. The natural gas powered emergency generator also failed.

Shortly after the battalion chief and the attack team reached the 11th floor there was a total loss of electrical power in the building. This resulted when intense heat from the fire floor penetrated the electrical room enclosure. The heat caused the cable insulation to melt resulting in a &ad short between the conductor and the conduit in both the primary and secondary power feeds, and the loss of both commercial power sources. The emergency generator should have activated automatically, but it failed to produce electric power. These events left the entire building without electricity for the duration of the incident in spite of several efforts to restore commercial power and to obtain power from the generator.

Electrical shaft enclosure on the 30th floor, showing side-by-side risers for the two power supplies, both damaged by fire penetration at the plenum level of the adjoining office space.

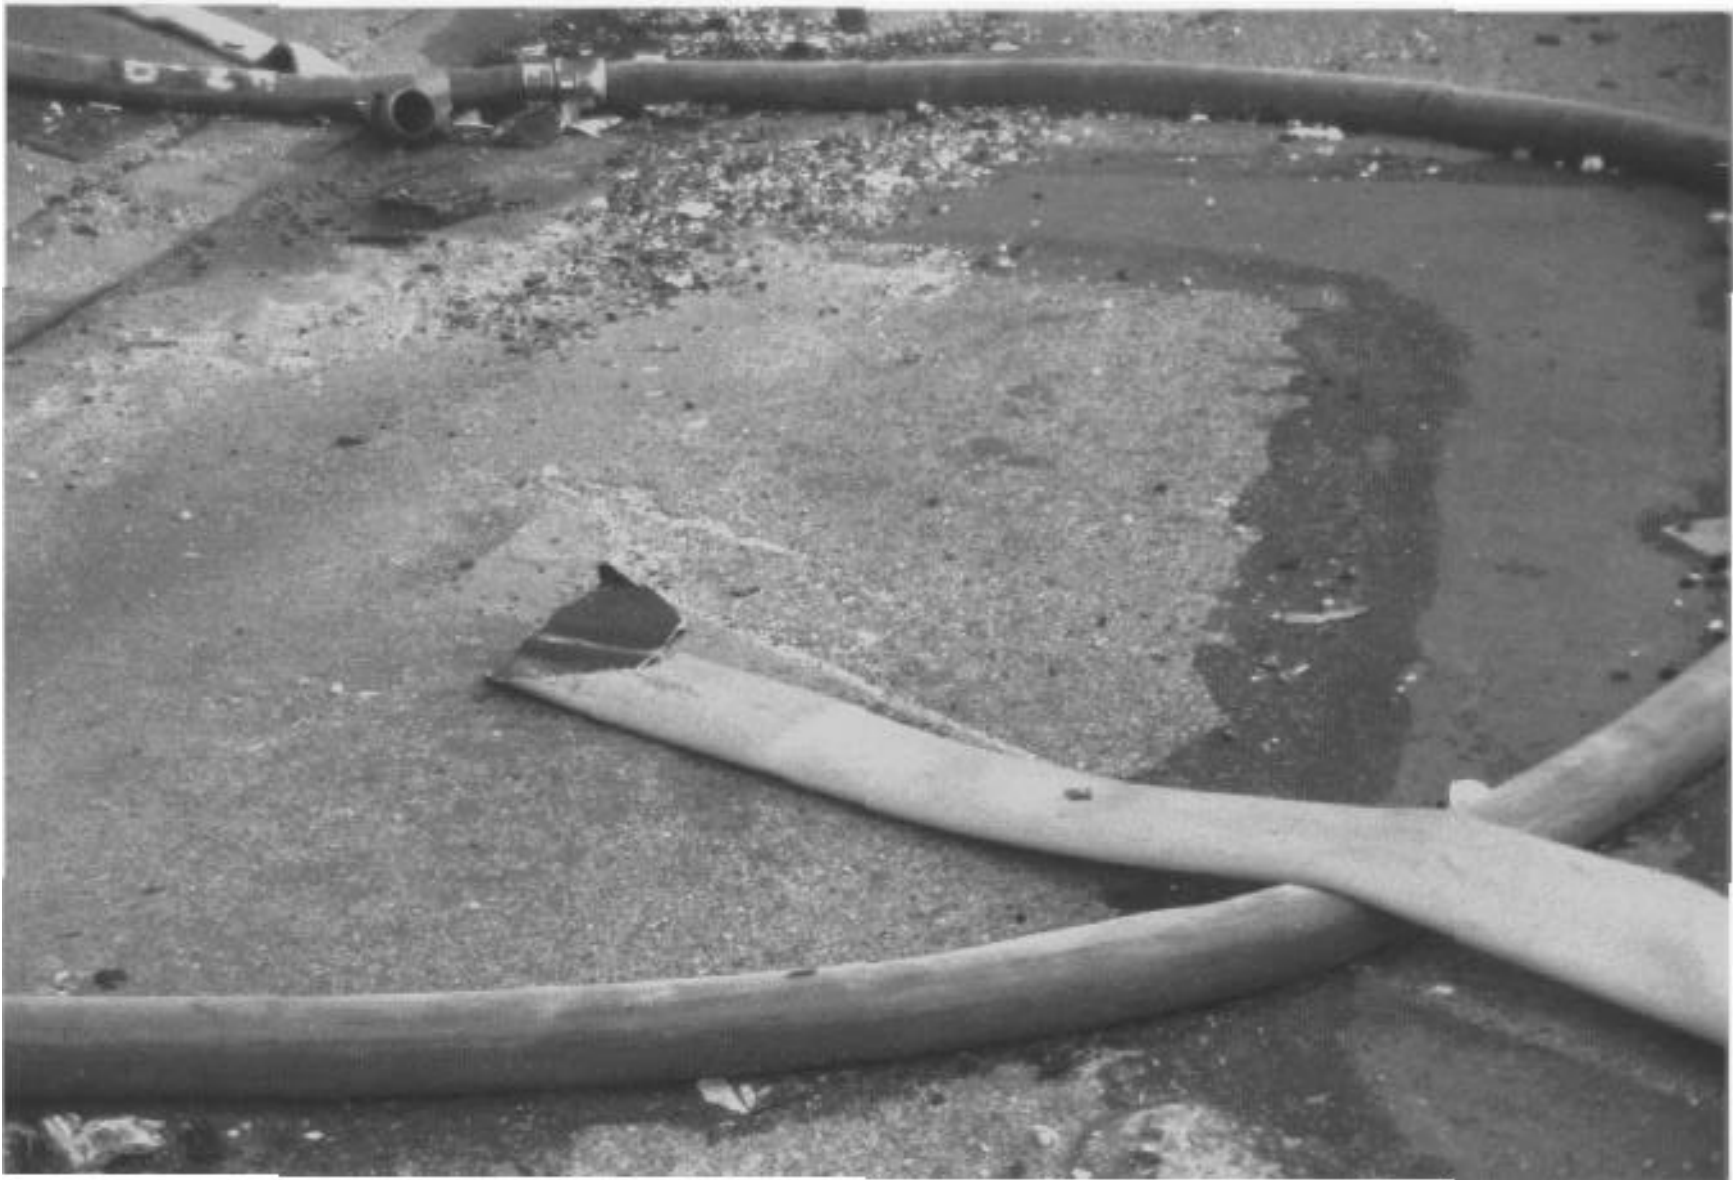
Section of 5-inch hose that was ruptured by falling debris outside the building. Hose lines feeding the standpipes and entering the stairways were damaged several times and had to be replaced at great risk to firefighters.
(Shoring boards were later used to protect the hose lines.)

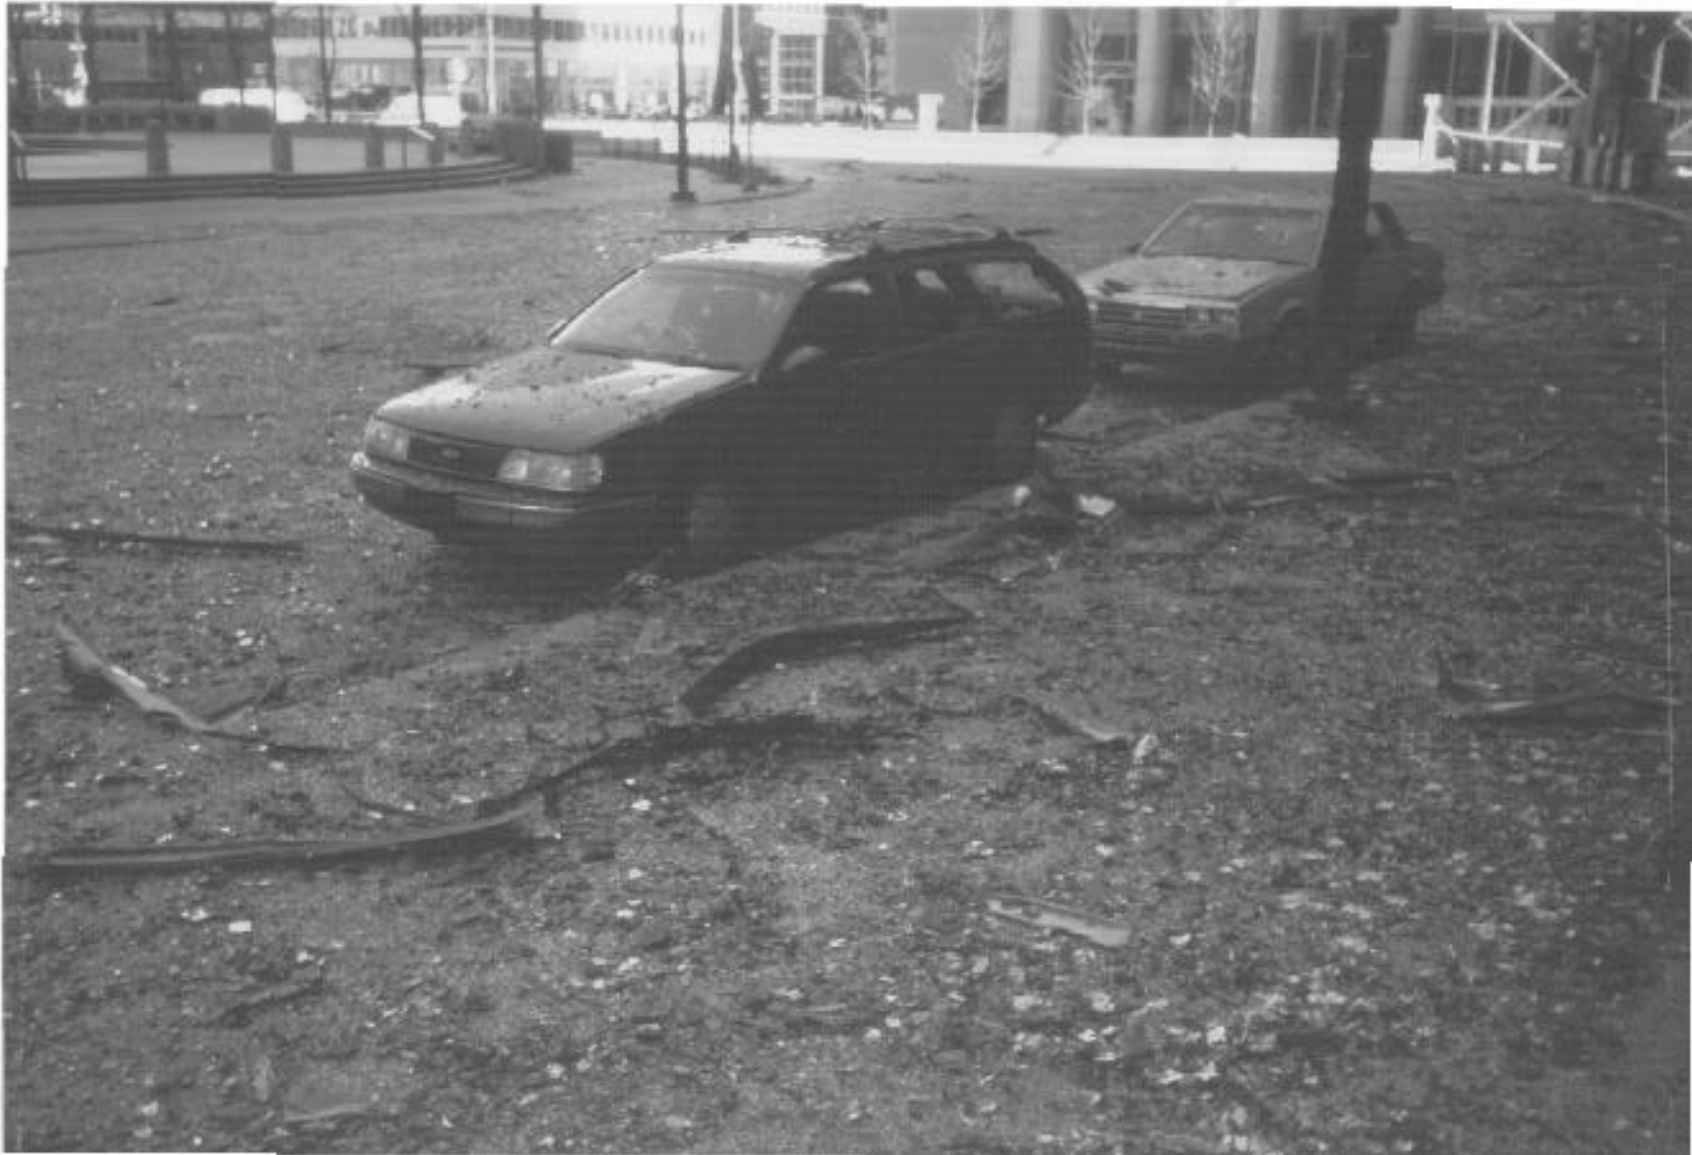
Street in front of the building from front steps showing stranded autos and debris in street.
