PRODUCT BULLETIN 3" and 4" Monitor Flange Connection Change

A design change has been made to combine the ANSI and DN bolt hole patterns on monitor connection flanges.

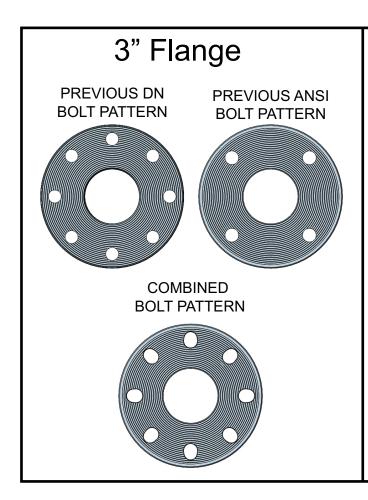
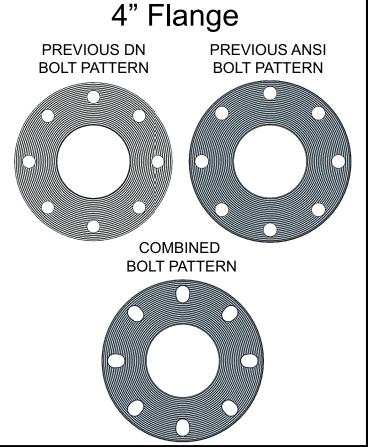
| Features and Benefits | |
|---|--|
| Slotted Bolt Holes | Allow for either DN or ANSI connection |

Combining bolt hole patterns simplifies the ordering process by using the same finished good number for ANSI or DN flanged products. Transition to the combined bolt pattern begins in August 2021. The following TFT monitor product lines are affected:
